Detonation
Pipeline
Chlorine
Hydrogen
Ferric chloride
Tracing system
Corrosion
Lock-out
Maintenance

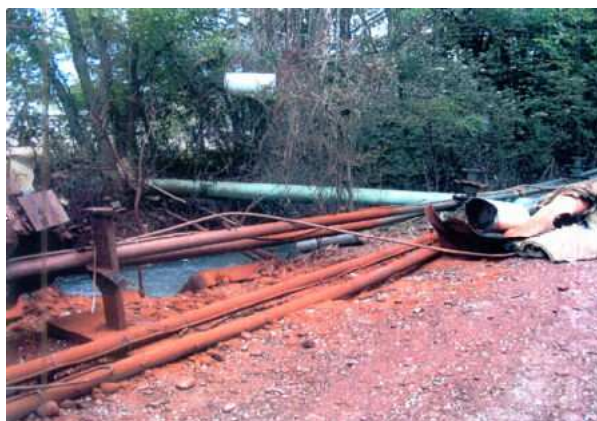
The accident claimed no victims. There was however substantial vegetation and material damage. Since the transfer of chlorine was suspended the previous day, the quantity of chlorine released into the atmosphere was estimated to be 475 kg. The chlorine transport line

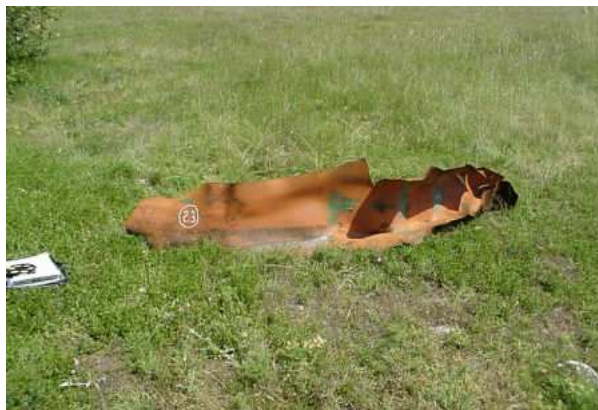
- The user site:
 - ✓ a 20 to 30 kg fragment at 180 m from the severed zone of the chlorine transport line ,
 - ✓ a 10 to 20 kg fragment at 150 m.
- In the field where the chlorine transport line is located :
 - ✓ a 30 to 40 kg fragment at 85 m,
 - ✓ a 10 to 20 kg fragment at 70 m.
- On the road heading North:
 - ✓ a 10 to 20 kg fragment at 60 m.

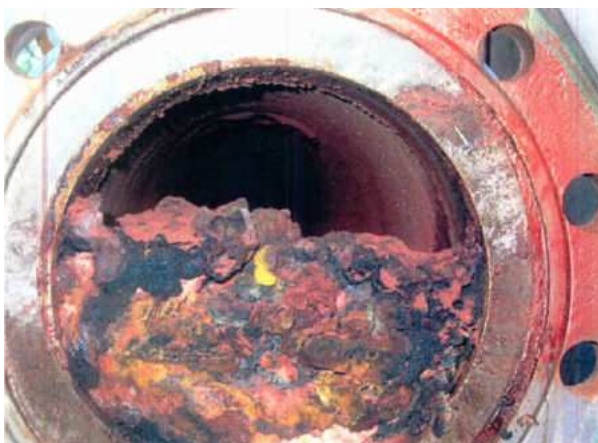
Among the several observations made during the enquiry, one of them included the presence of considerable amounts of solid deposits in the exploded pipeline.

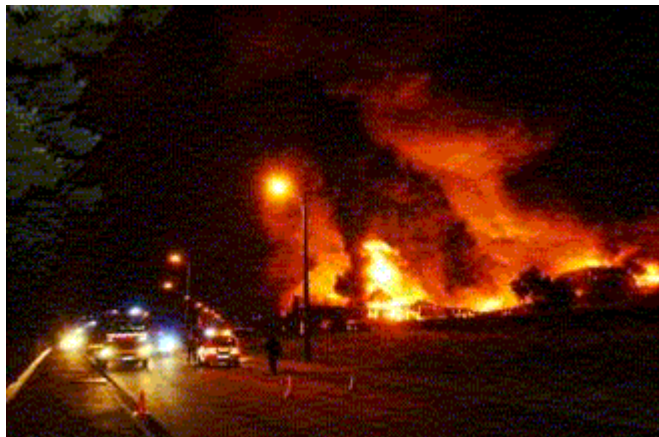
Buildings on fire

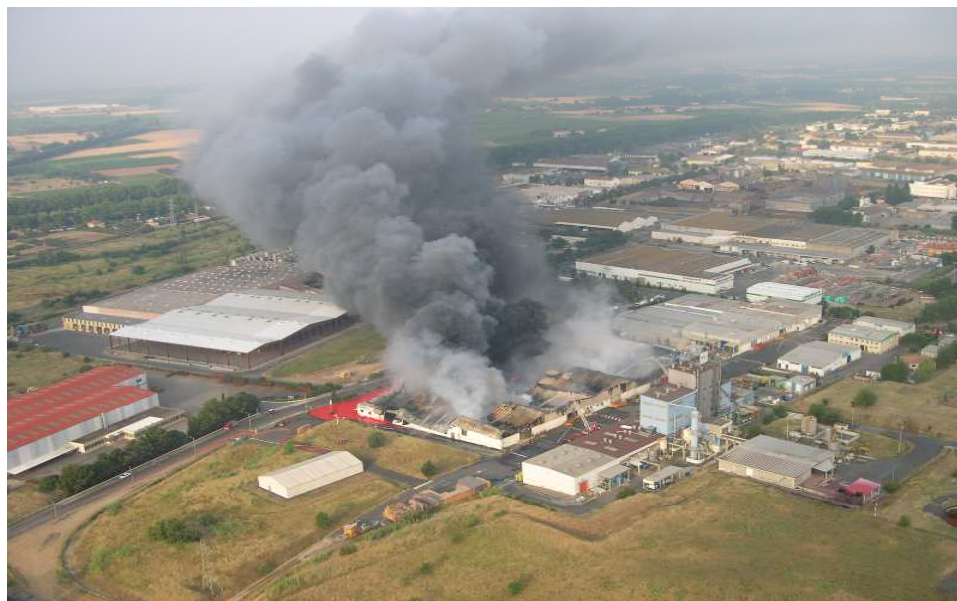
Plume of smoke rising above the site

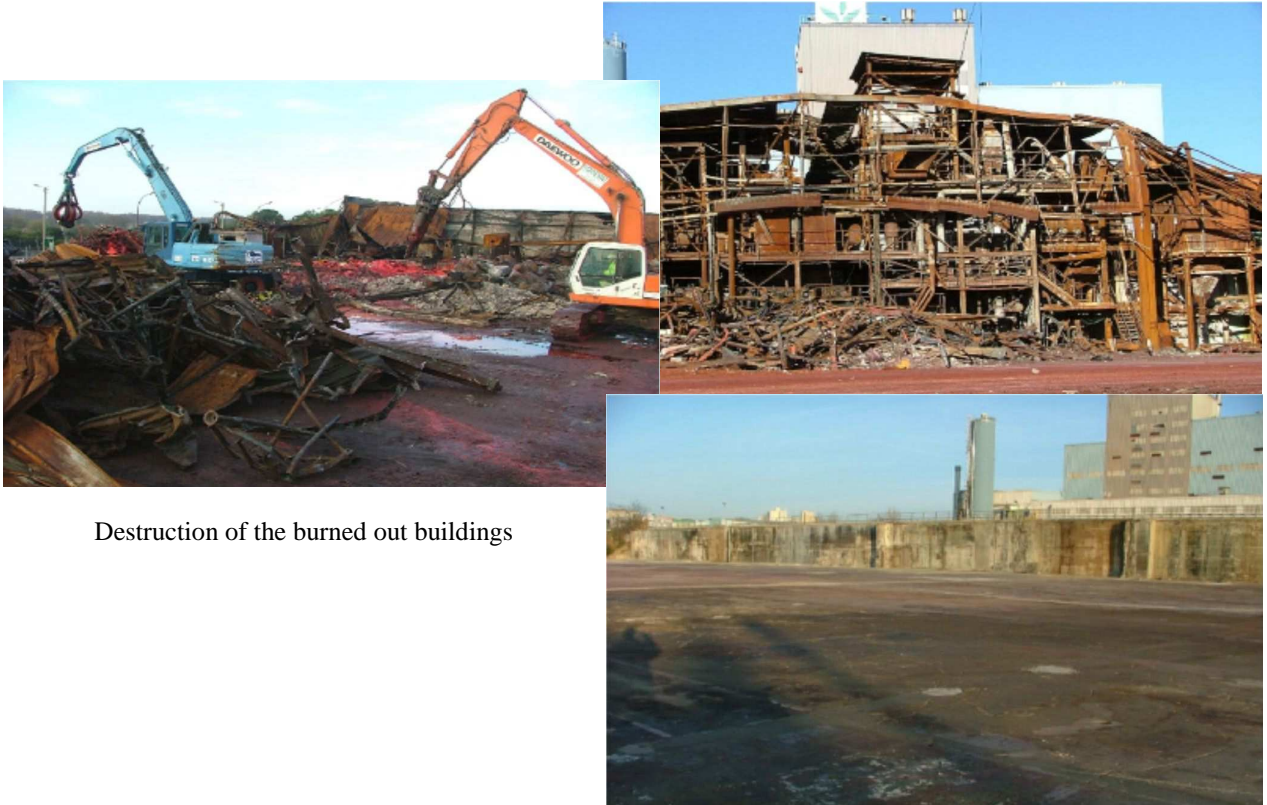
Destruction of the burned out buildings

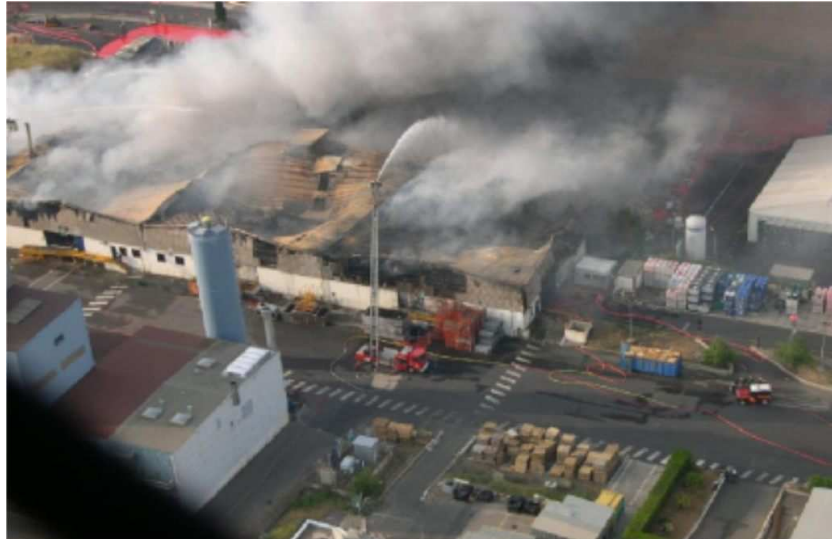
Spread of the fire to several buildings

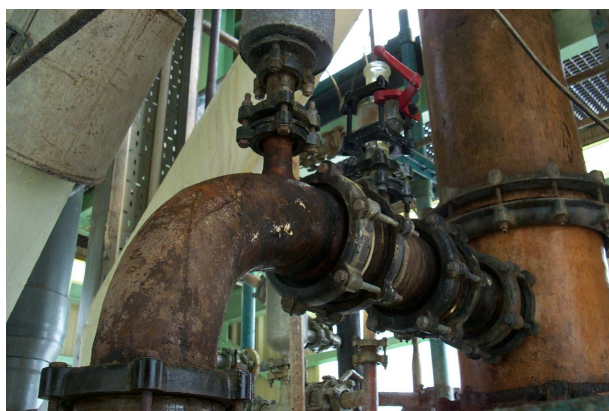
At 11.30 am, with the installation still shut down (heating setpoint at 0%, valves closed), the maintenance technician observed that it was impossible to drain the boiler when attempting to remove the pressure sensor in place.

Branch connection exiting the boiler (Sources: DRIRE Picardie)

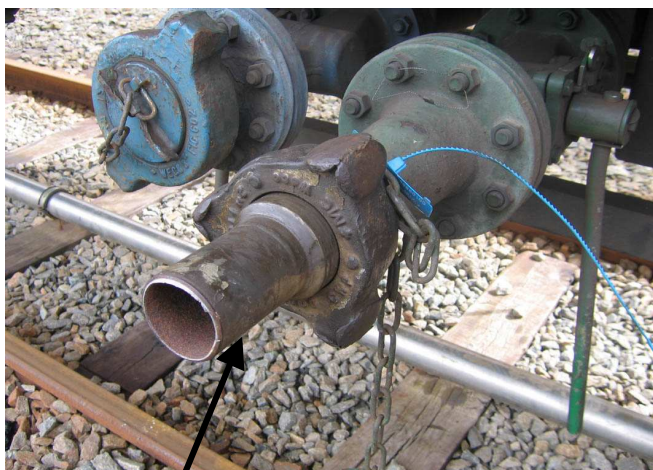
The incident had no consequence for the personnel present. Approximately 8 litres of liquefied propane was released, corresponding to the volume of the coupling that was severed.

The severed coupling

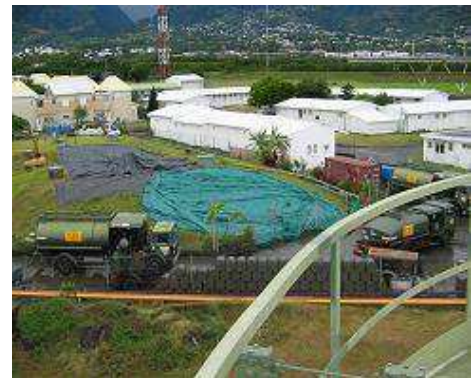
▲ Product infiltration zones (photo DR)

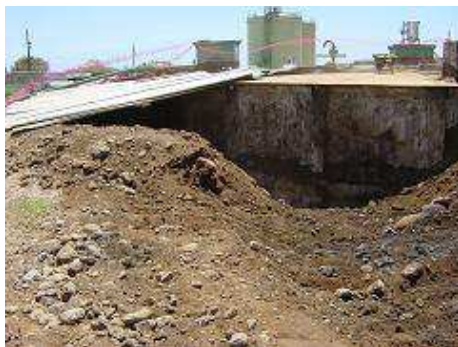
▲ Digging operations round the SEA2 tank (Photo DR)

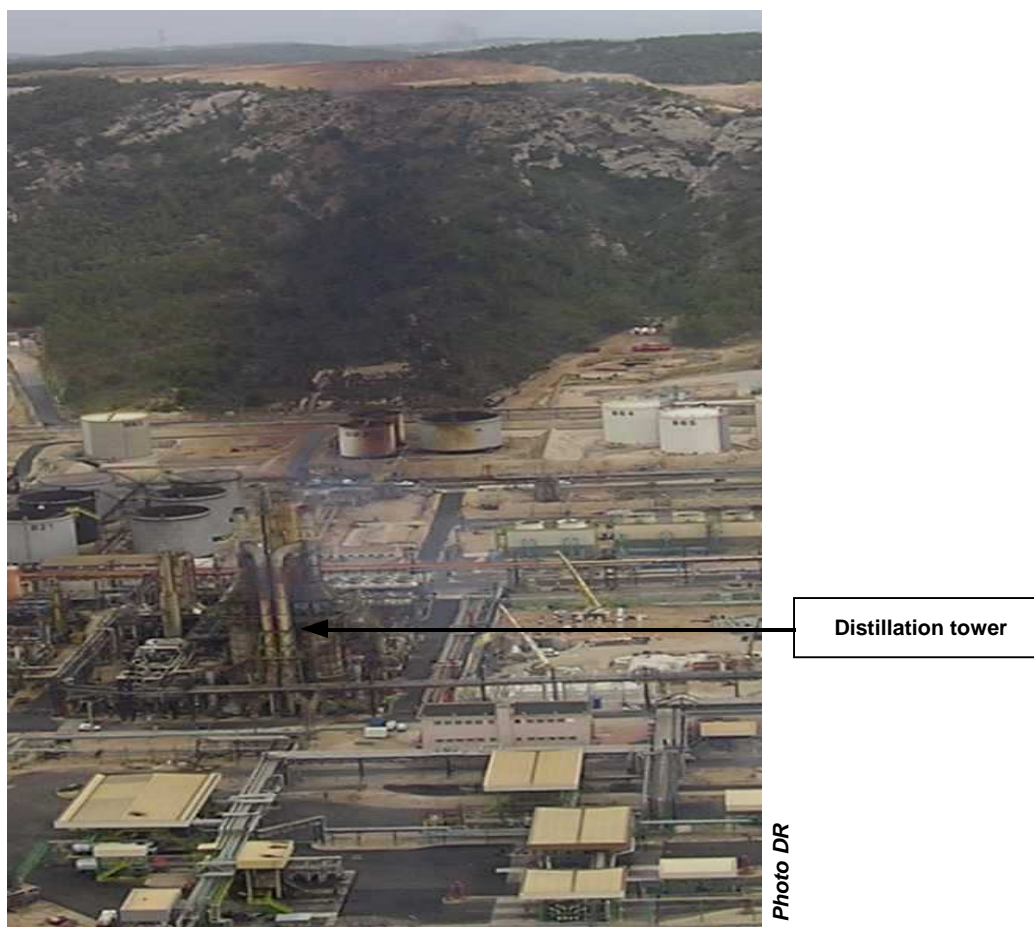
General aerial view of the unit and traces of spill in the neighbouring environment.

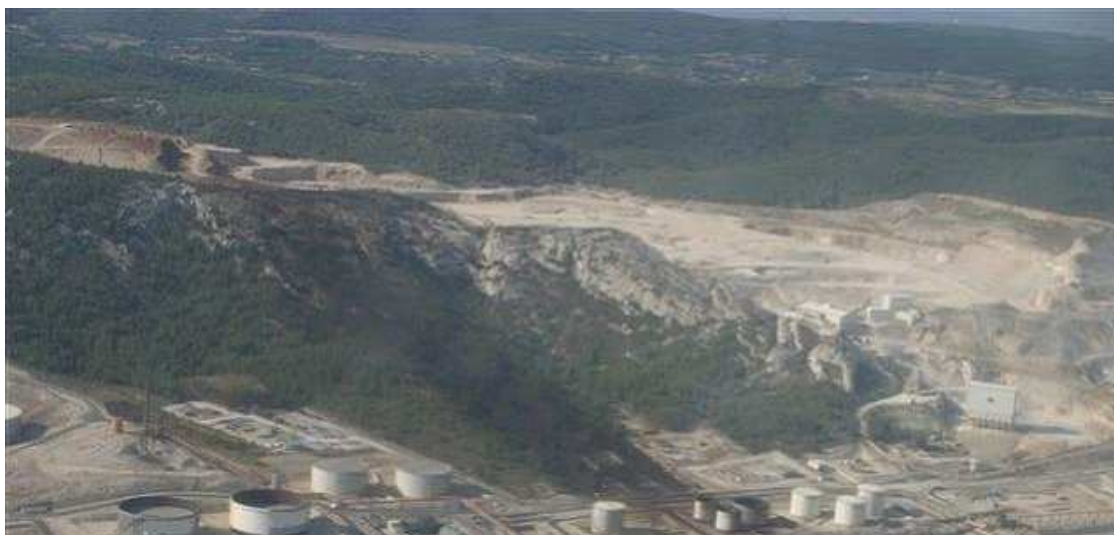
General aerial view of the unit and traces of spill in the environment south of the site

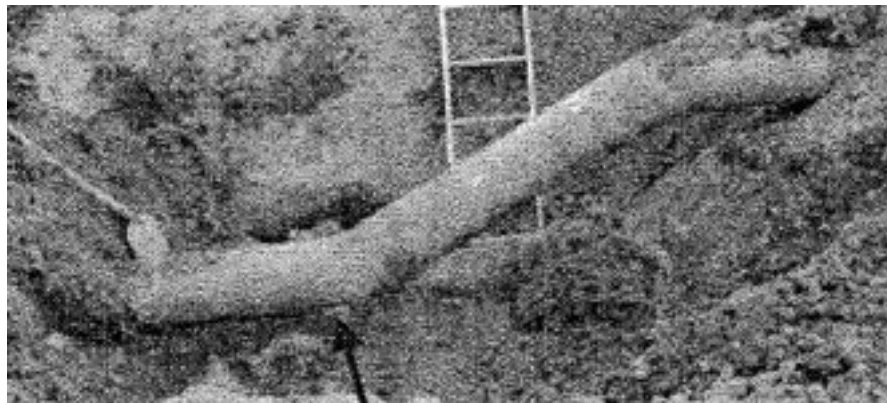
Despite annual inspections, the leak appeared to have existed for a number of years; the leak's initially low flow rate most likely increased progressively due to soil movements.

Portion of damaged pipeline
Source: VROM-Inspectie (The Netherlands)

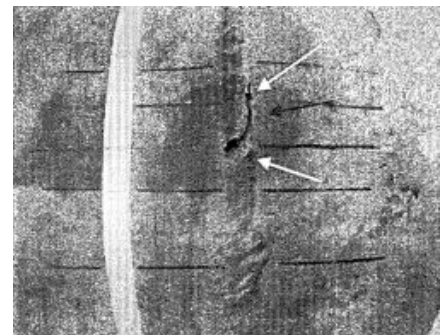
Crack on the weld
 Source: VROM-Inspectie (The Netherlands)

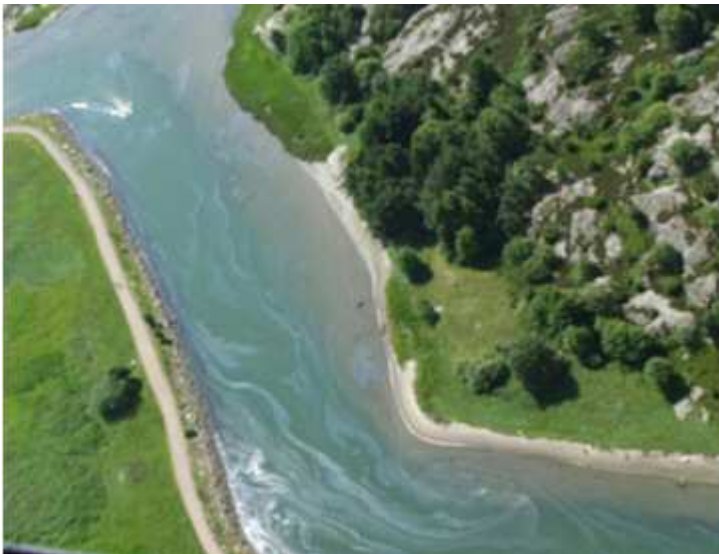
Environmental consequences of the spill of heavy fuel oil in the oil harbour.

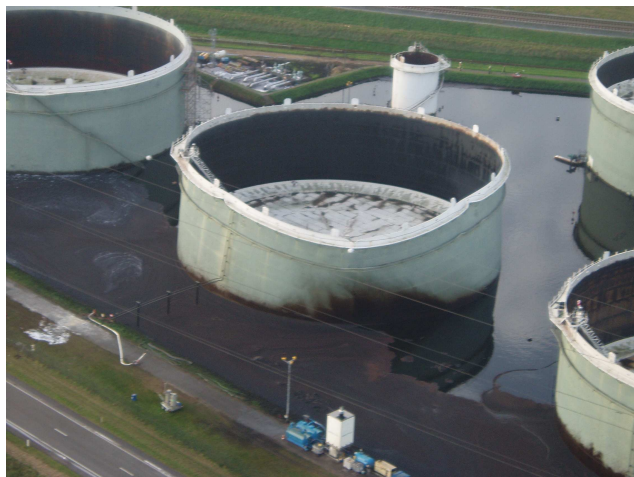
Figure 1 shows a picture of the situation in the bund the morning after the major accident happened.

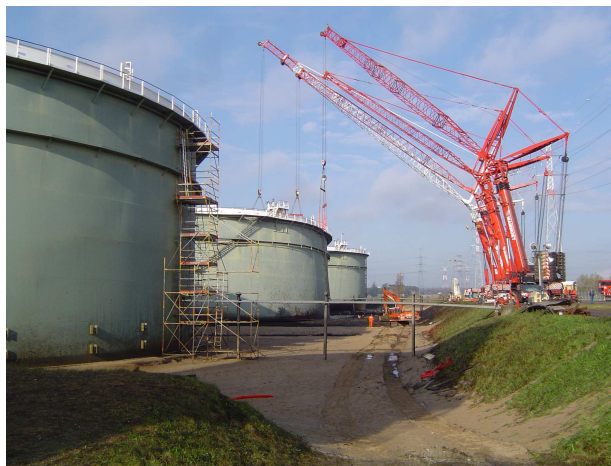
Figure 4: Major cranes stabilising tank D2
